DEPARTMENT OF THE ARMY
UNITED STATES ARMY AVIATION TEST BOARD
Fort Rucker, Alabama 36360

SUBJECT: ~~Letter Report~~ "Product Improvement Test, T53-L-11
Metal Spray Repaired Engine," ~~ADT&E~~ Project No.
5-0151-13, USATECOM Project No. 4-

ENGINEERING ANALYSIS

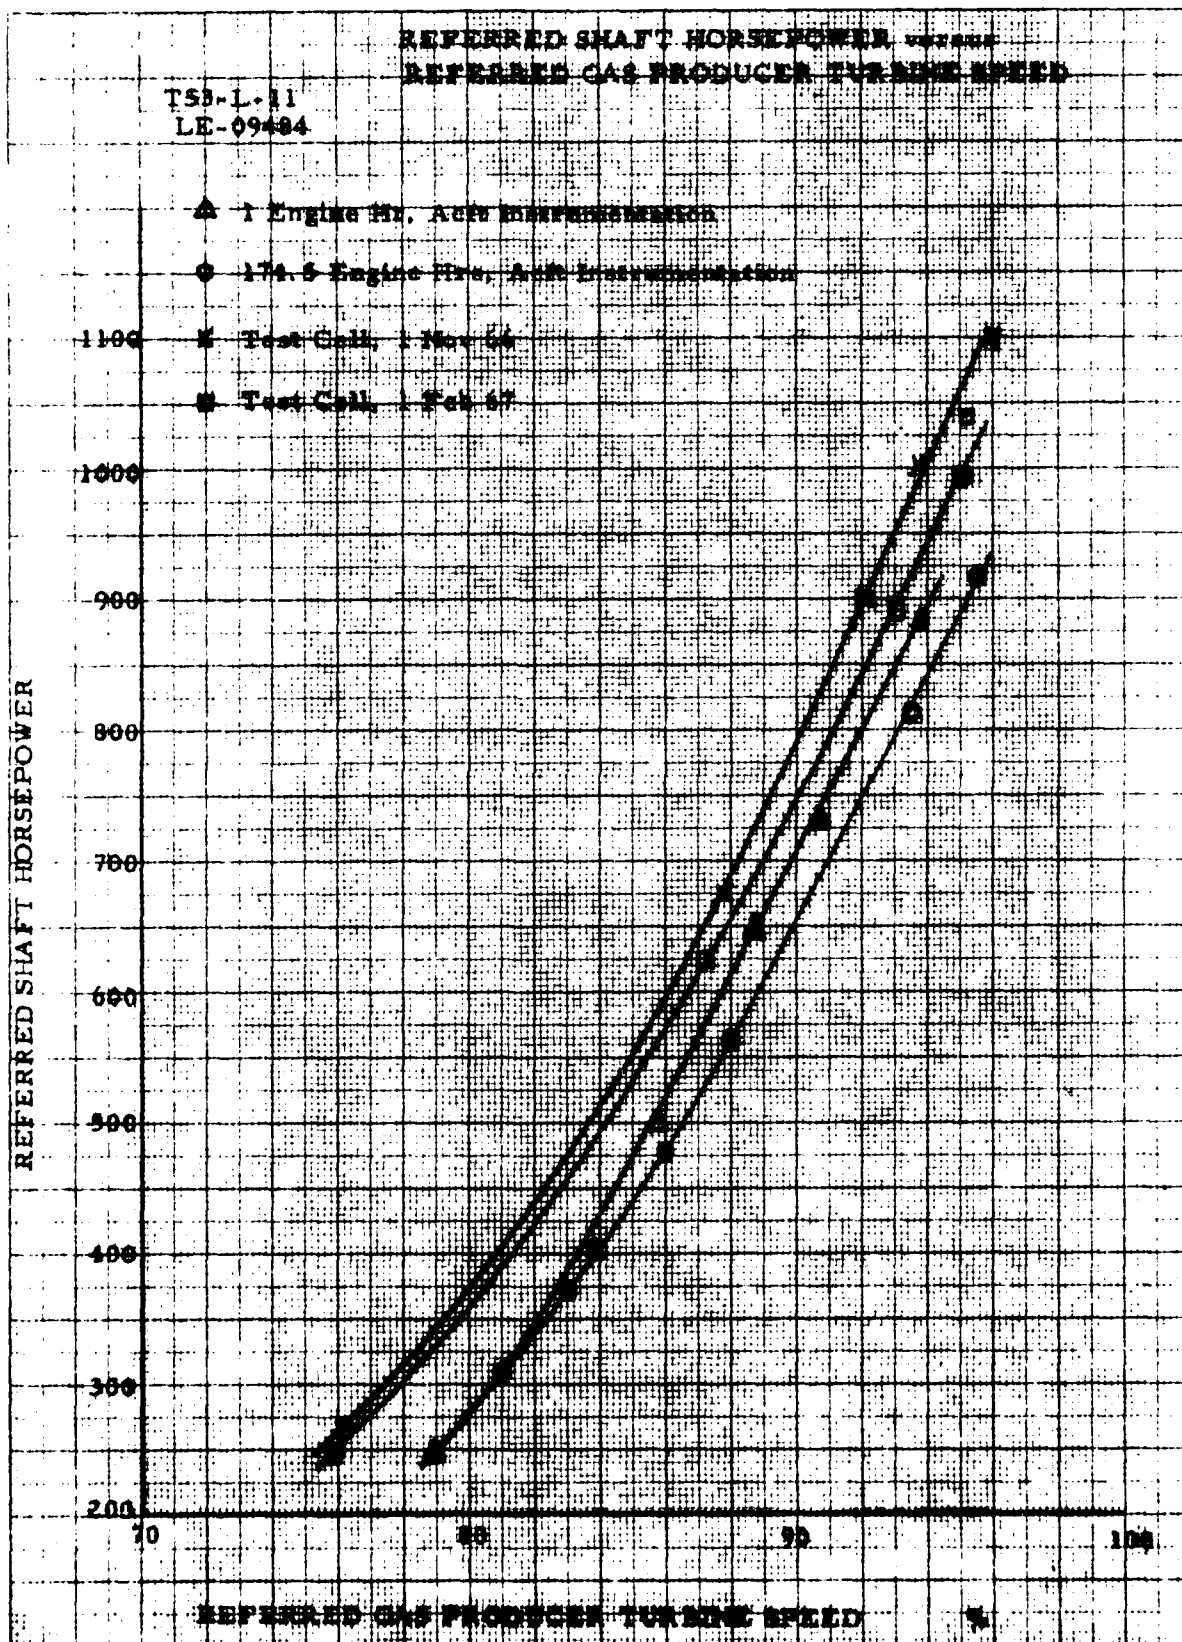
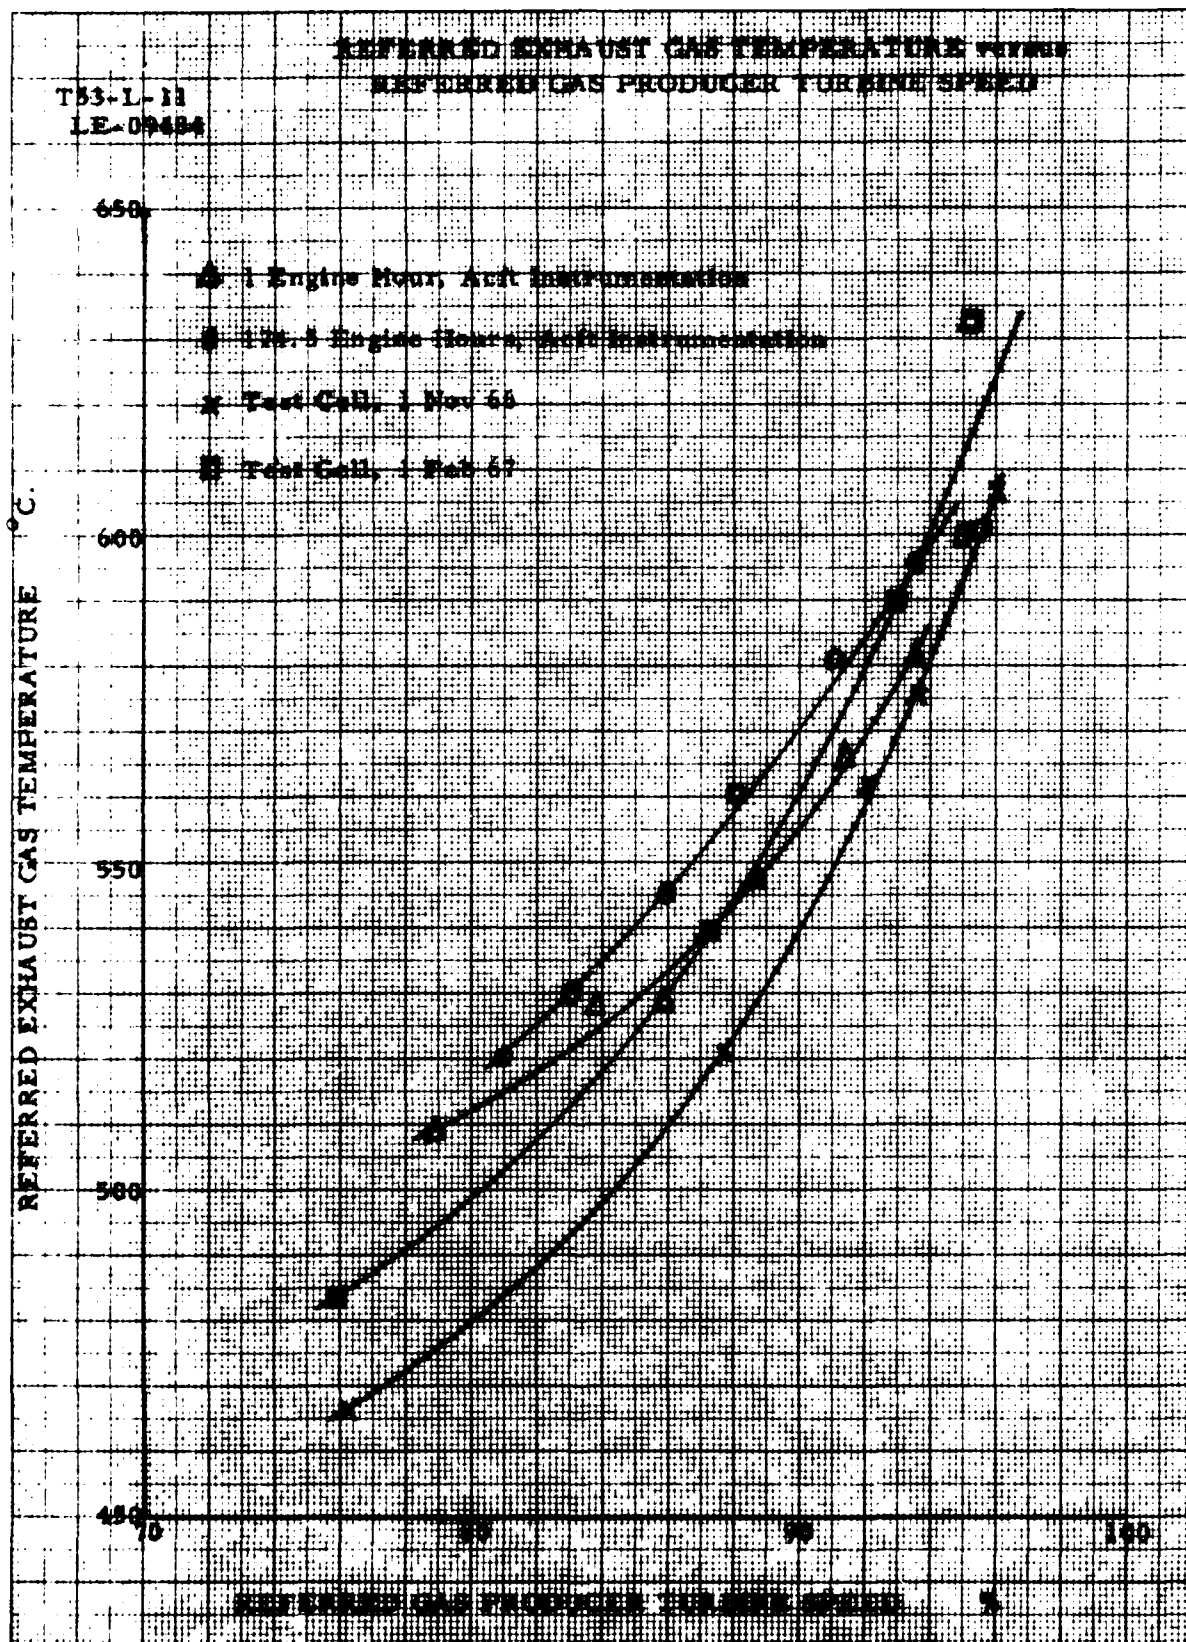
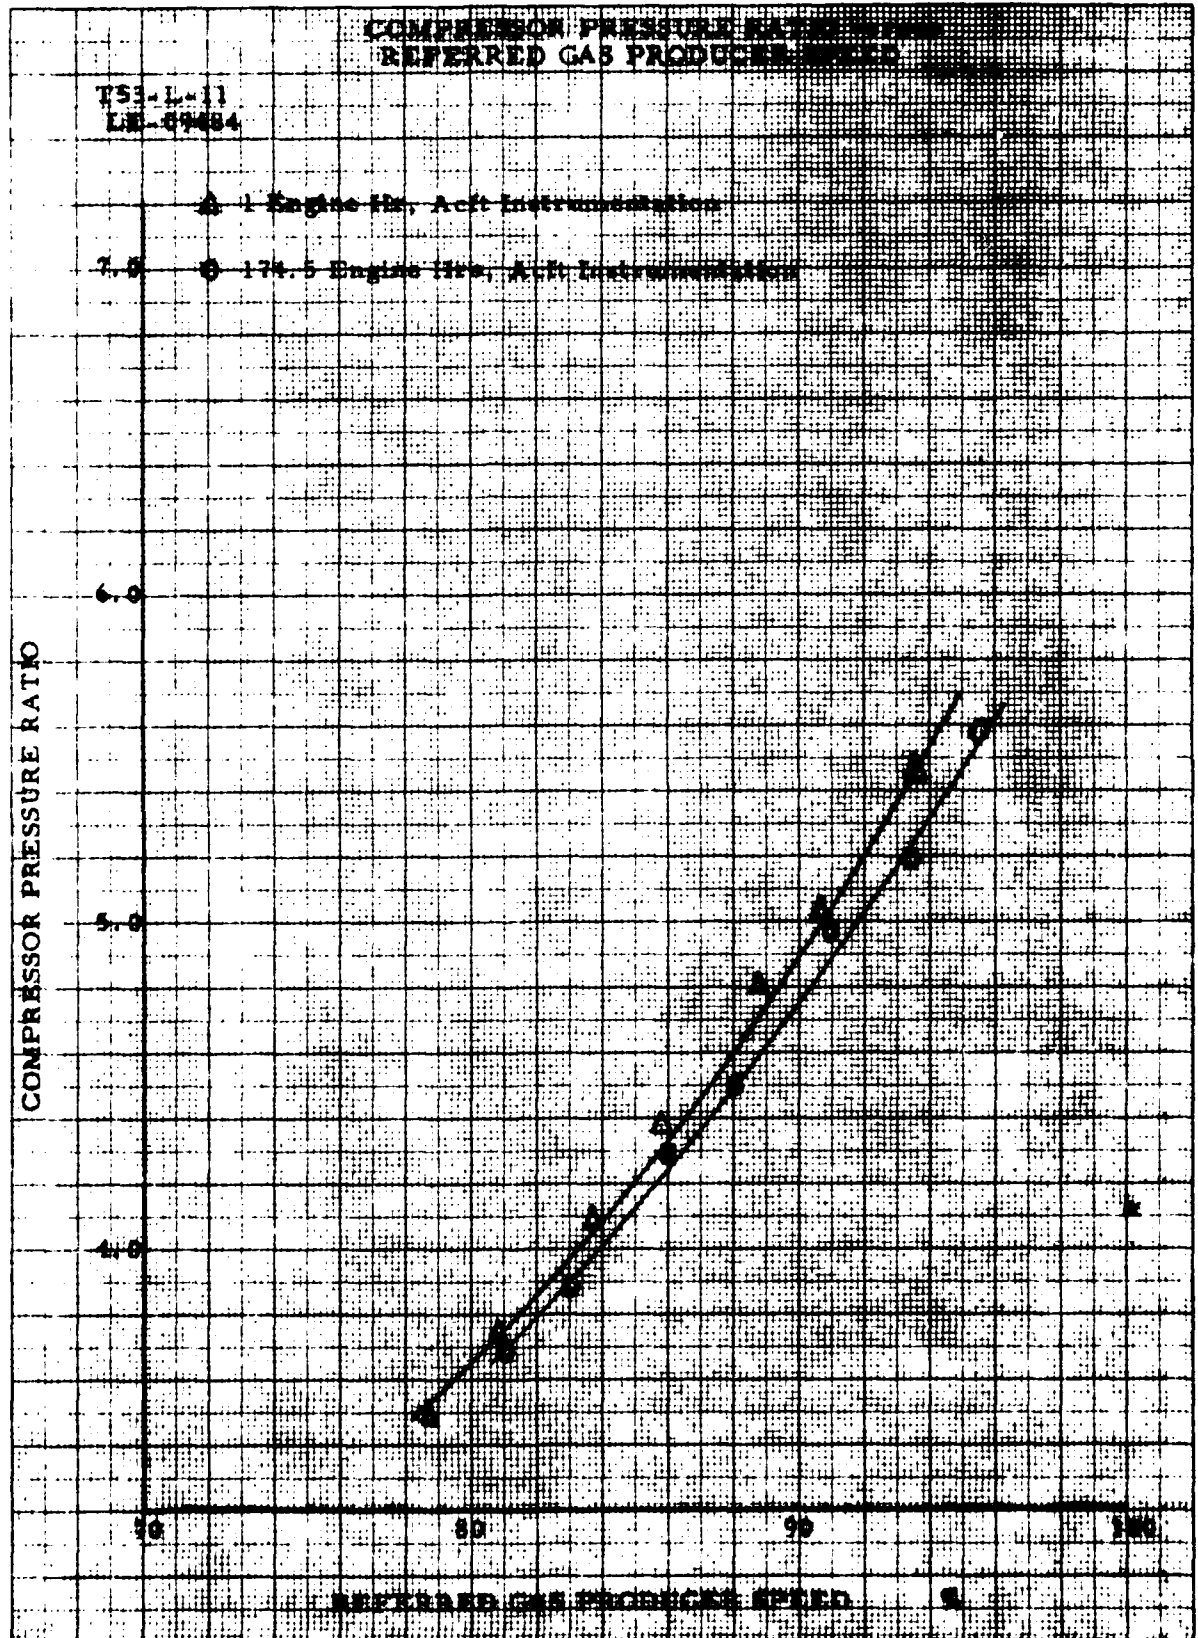
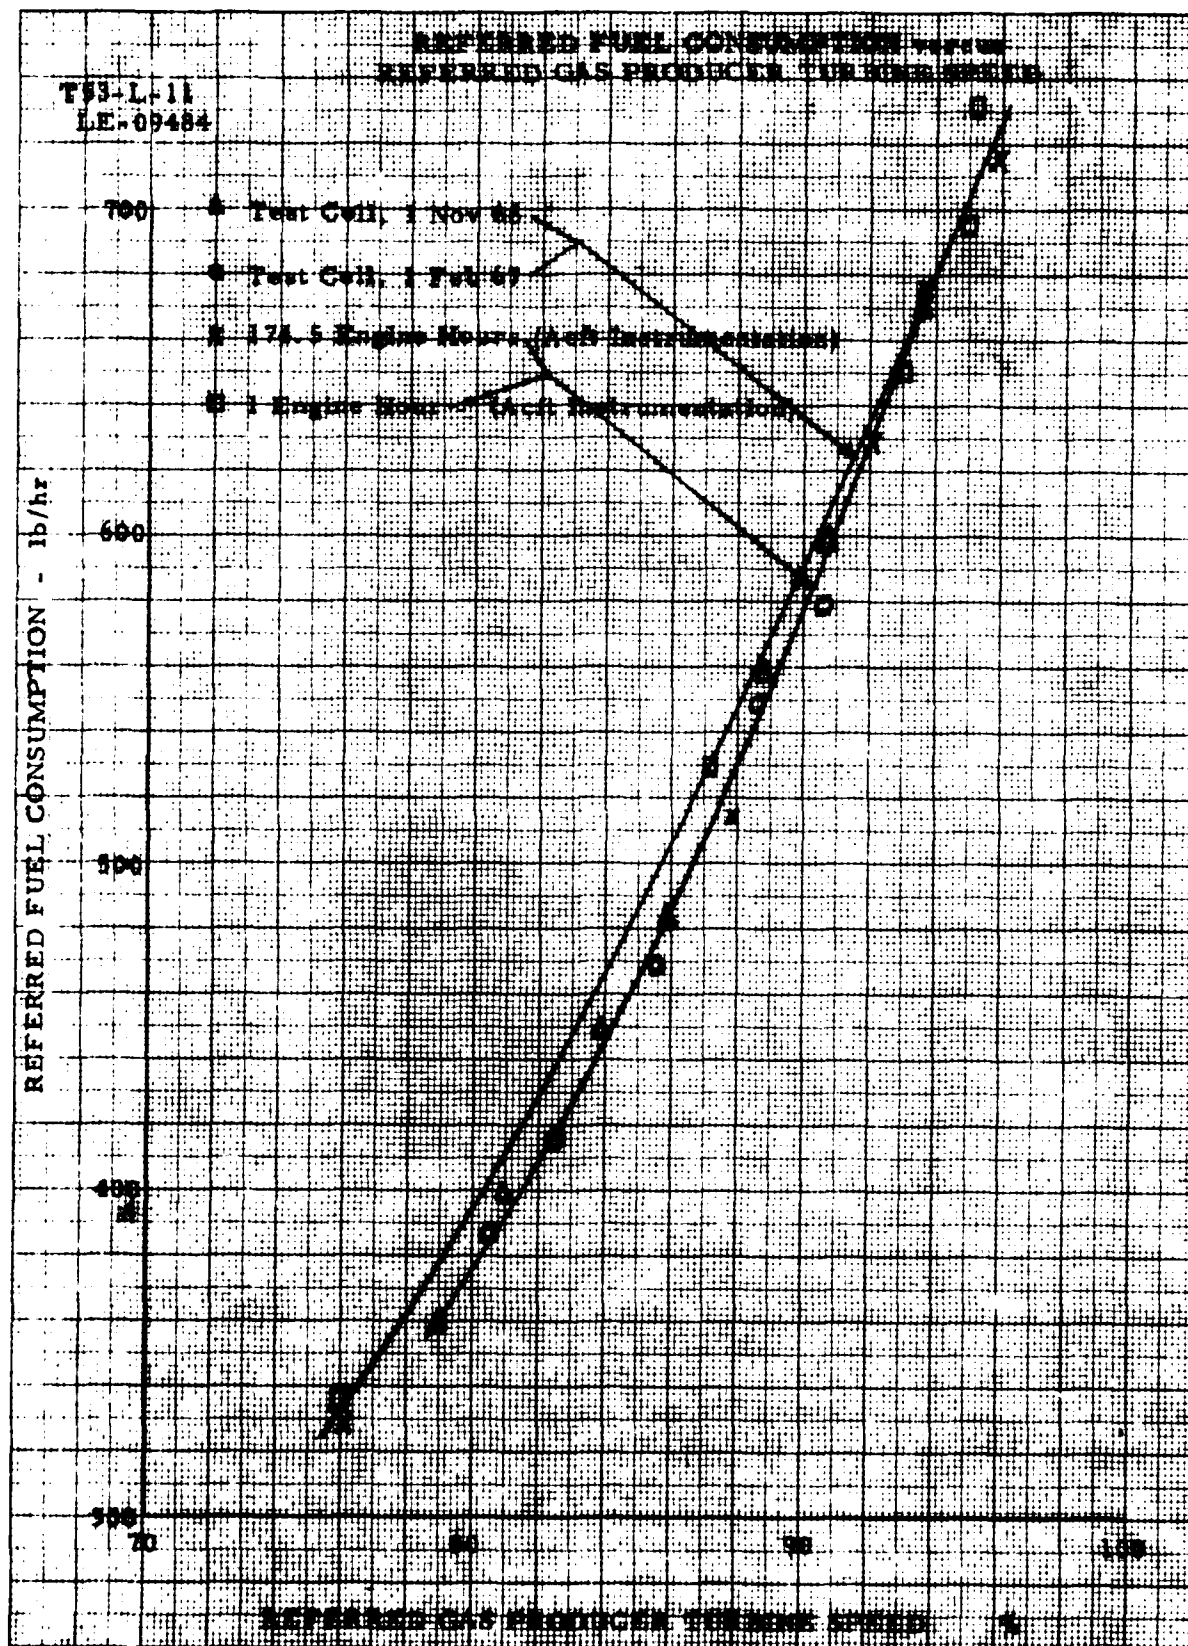
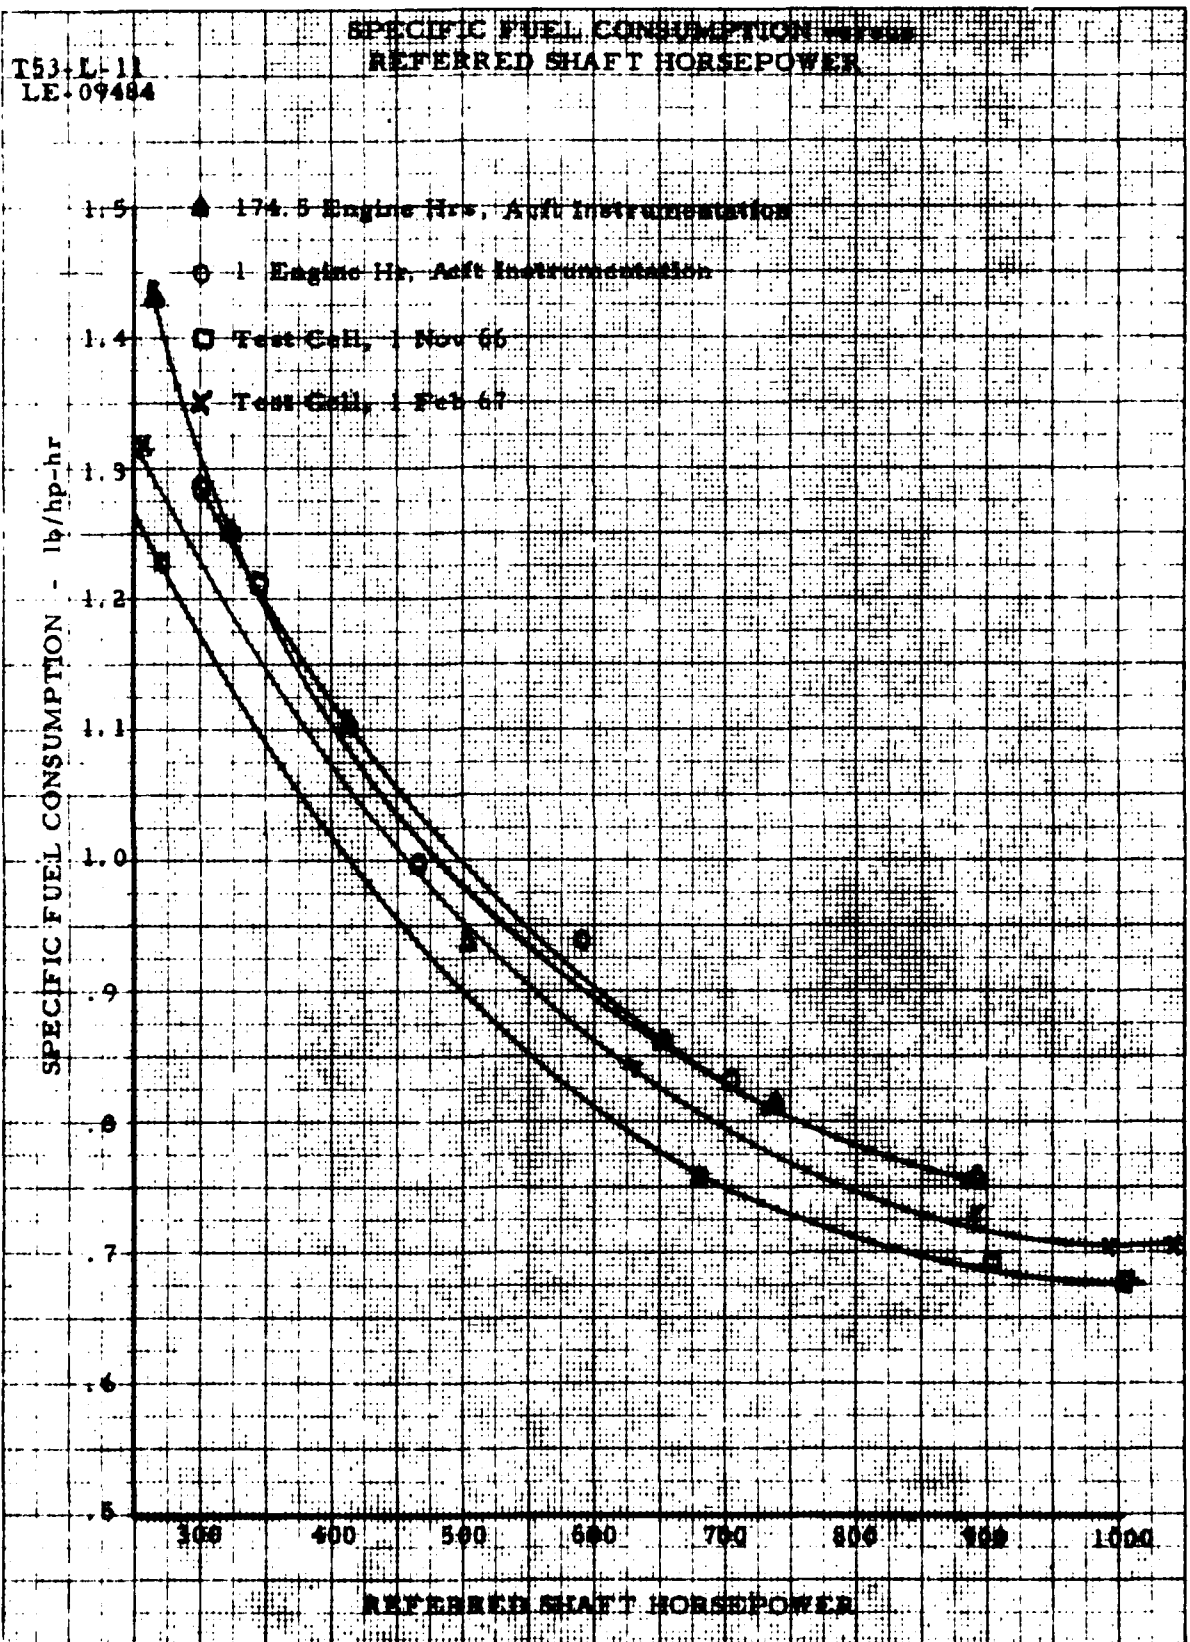
A graphic indication of the change of engine performance after 174.5 engine hours (3.6 sand hours) can be seen in figures 1, 2, 3, 4, and 5.

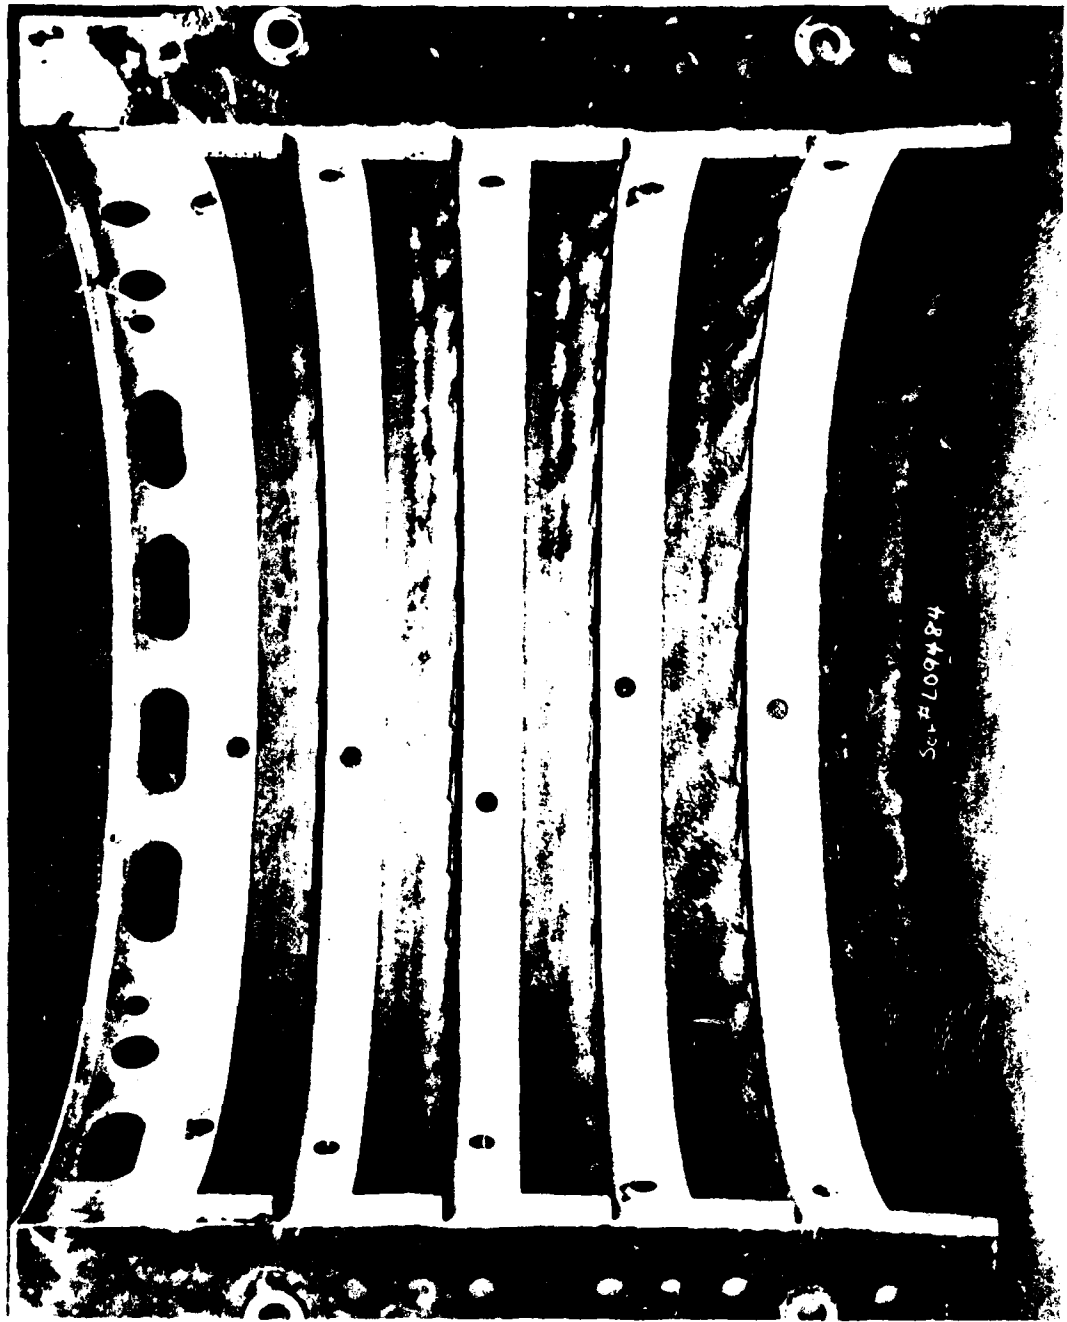
Figure 27.

4. The engine was disassembled for inspection at USAADMAC after the test was terminated at 174.5 engine hours (3.6 sand hours). Figure 27 shows the general condition of the top case of the compressor. Inspection of the lower half of the compressor case revealed that it sustained far greater erosion damage than did the top half of the case. The condition of the lower half of the compressor case is shown in figure 28 (left side, forward section), figure 29 (right side, forward section), figure 30 (left side, rear section), and figure 31 (right side, rear section). The condition of the centrifugal impeller housing is shown in figures 32 and 33. The general condition of the rotor assembly is shown in figure

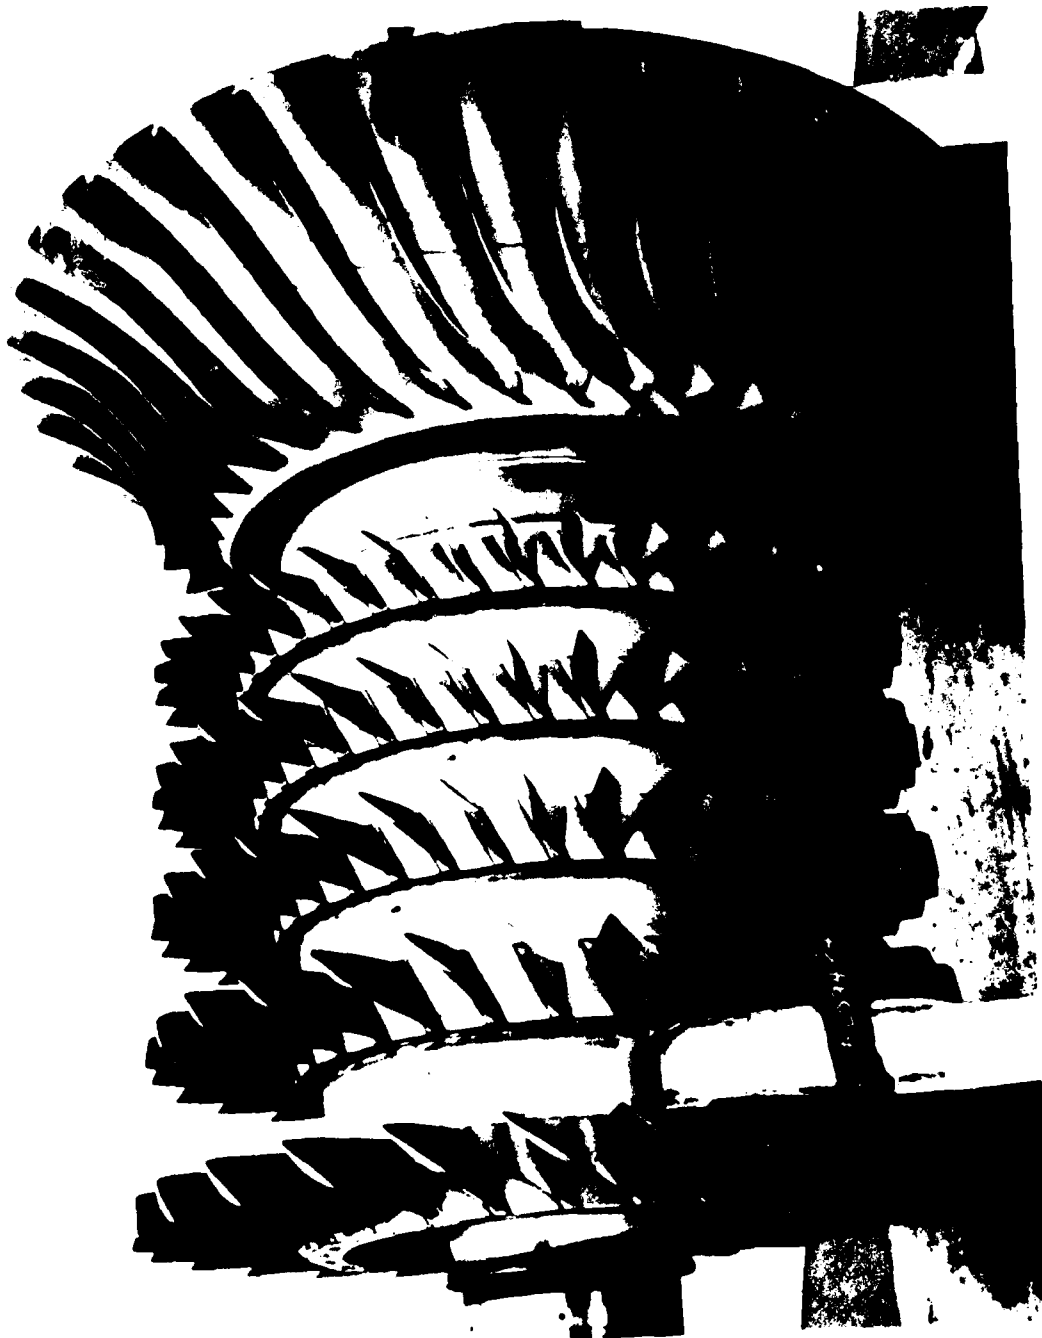
Figure 64.

34. Some foreign object damage was evident, and the trailing edges of the blades at the outboard end were thinned and twisted up toward the convex side of the blade.

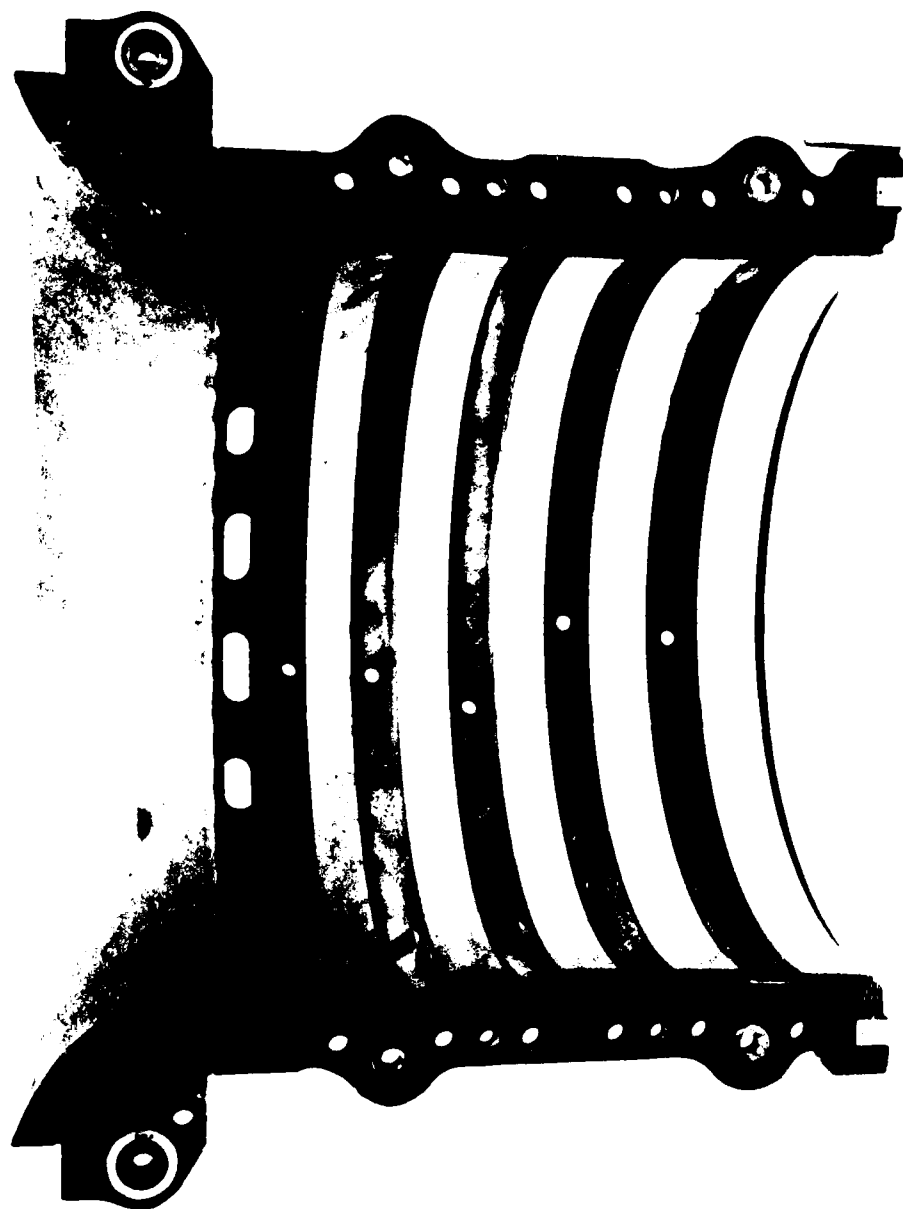
Figure 35.

1. The general condition of the axial and centrifugal compressor housing of the baseline engine (S/N LE-10420) after 3.8 hours of sand exposure is shown in Figures 35 and 36. It would appear that the erosion of the axial compressor land areas of the metal-spray repaired engine (S/N LE-09484) after 3.6 hours of sand exposure is more severe than the erosion of the land areas of the baseline engine. Comparison of the trailing edge outboard blade tips of the axial compressor blades, however, indicated the blade tips on the baseline engine (S/N LE-10420) had eroded to a rounded-off condition (Figure 37). The trailing-edge outboard blade tips of the metal-spray repaired engine were thinning and rolling up toward the convex side (Figure 34), but had not eroded away like those in the baseline engine.

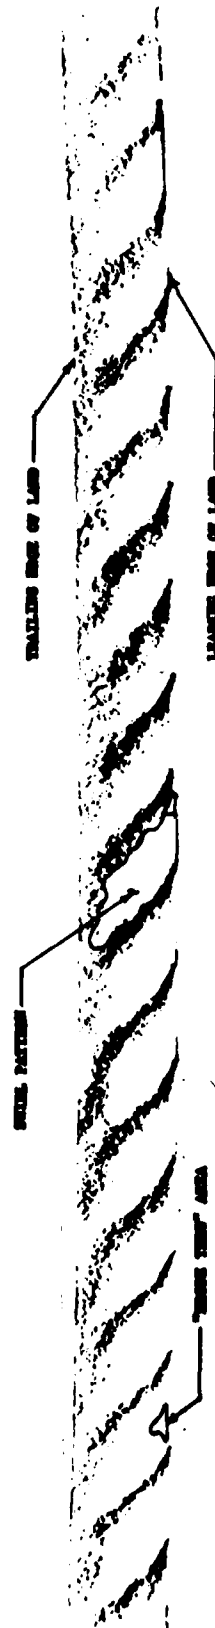
FIGURE 1

d. There are indications that the erosion mechanism starts by eroding out a small thin chip of metal spray just aft of the leading edge of the land. After the chip is removed, the erosion mechanism continues by picking out particles (which would be similar in effect to sanding) and the now common "SWIRL" pattern is thus formed. There is no evidence of compressor damage from the small initial metal spray chips, which indicates immediate fragmentation upon first impact with a compressor rotor blade. This conclusion is substantiated, to a degree, by examining the porous, laminated structure of the bronze metal spray, which would lend to fragmentation upon impact.

The down impression of the second stage land shows typical "wrist" patterns caused by sand and dust erosion. The dark areas are the peaks (high spots) and the light areas are the valleys (low spots). One "wrist" area was drawn in to show the shape and location, and also the point of deepest erosion.

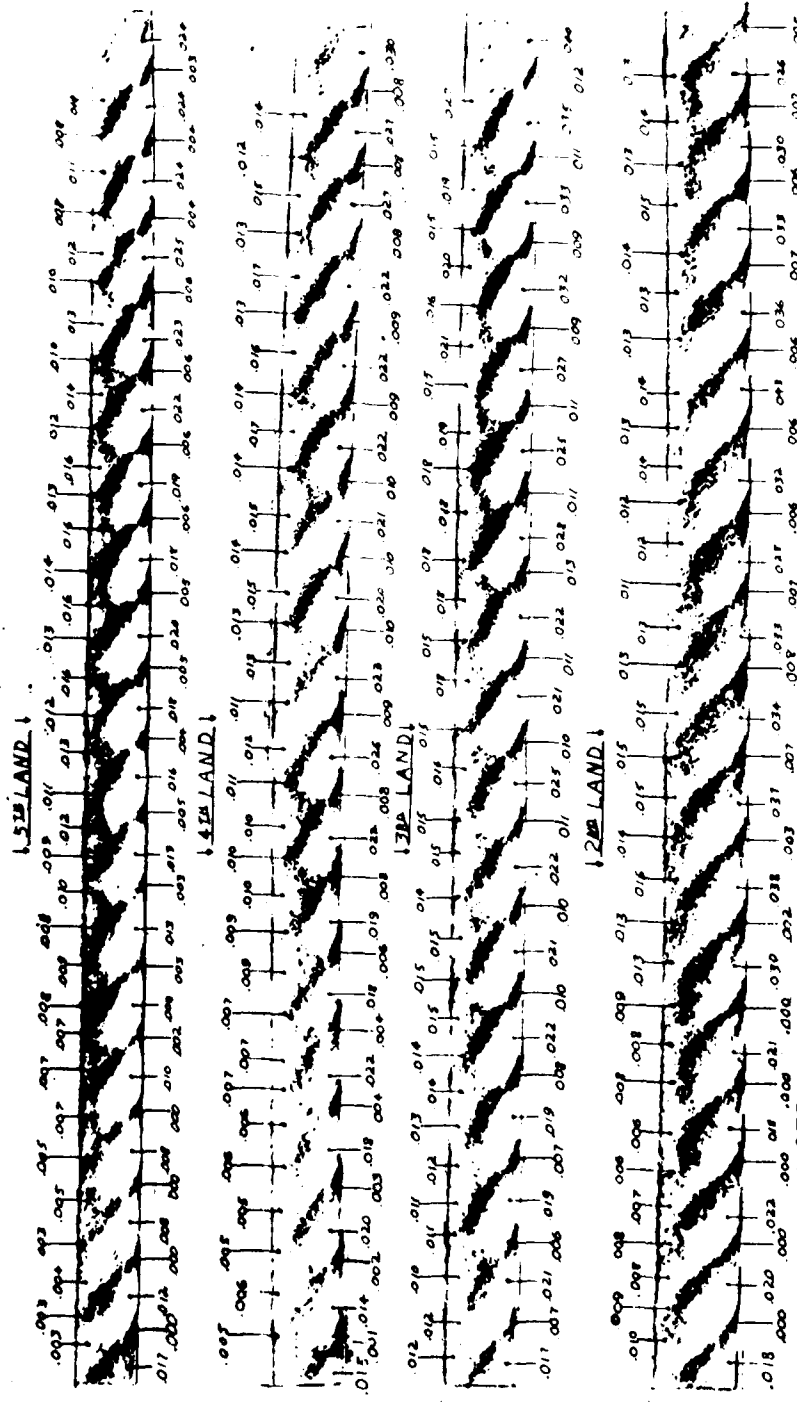
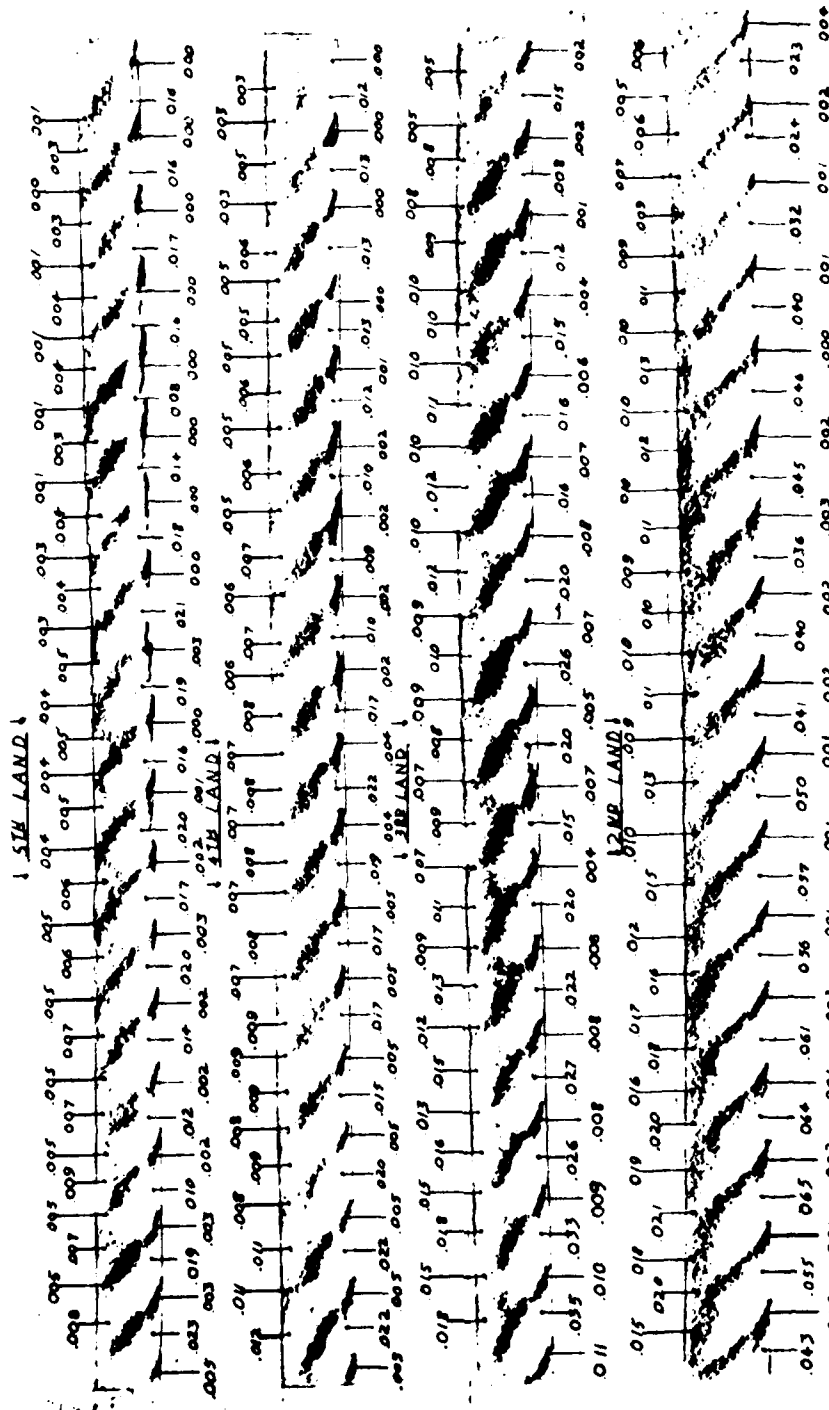
b. The greatest erosion damage was realized on the second stage land (bottom of housing) in which 12 of the 18 "SWIRL" patterns show erosion thru the bronze coating and into the base metal. There is no other area of the housing showing erosion thru the coating system, including the 2nd stage land in the top half of housing. Nine of the twelve "SWIRL" patterns, which are eroded thru the coating, are between the 3 o'clock and the 6 o'clock position (as looking upstream). The erosion damage progressively gets more severe from the 6 o'clock position to the 3:45 o'clock position, on second stage land, where it is the most severe. From the 3:45 o'clock position damage quickly decreases and becomes almost constant around the top half of the housing. The "erode thru" areas are just aft of the leading edge and in all cases are surrounded by metal spray. (The leading edge of the land is "shadowed" and thus is protected by the aft edge of the stator vane outer shroud.) The pattern of the "eroded thru" area at the bottom of the more advanced or deeper "SWIRL" patterns is shaped like the profile of a wave (see Figure 1), the base of which is parallel to, and just aft of, the leading edge of the land. The largest area of "ERODE THRU" naturally in the deepest SWIRL pattern, which is located only 2 inches down from the split flange (3:45 o'clock position as looking up stream). The width of this "wave profile," at its base, is approximately .330 inch, and the height is approximately .175 inch. The depth of this swivel pattern is .065 inch below drawing dimensions.

c. The erosion damage on all lands seems to be concentrated on the forward half of the land surface. See Figure 2 for complete outline of erosion pattern with dimensional data.

NOTE: DIMENSIONS SHOW EXTENT OF EROSION BELOW DRAWING DIMENSIONS
 FIGURE 2 (SHEET 1)
 IMPRESSIONS OF SECOND THROUGH FIFTH LANDS TO SHOW EROSION DAMAGE
 TOP HALF OF AXIAL COMPRESSOR MSG.

NOTE: DIMENSIONS SHOW EXTENT OF EROSION BELOW DRAWING DIMENSIONS
 FIGURE 2(SHEET 2)
 IMPRESSIONS OF SECOND THROUGH FIFTH LANDS TO SHOW EROSION DAMAGE
 BOTTOM HALF OF AXIAL COMPRESSOR MSG.

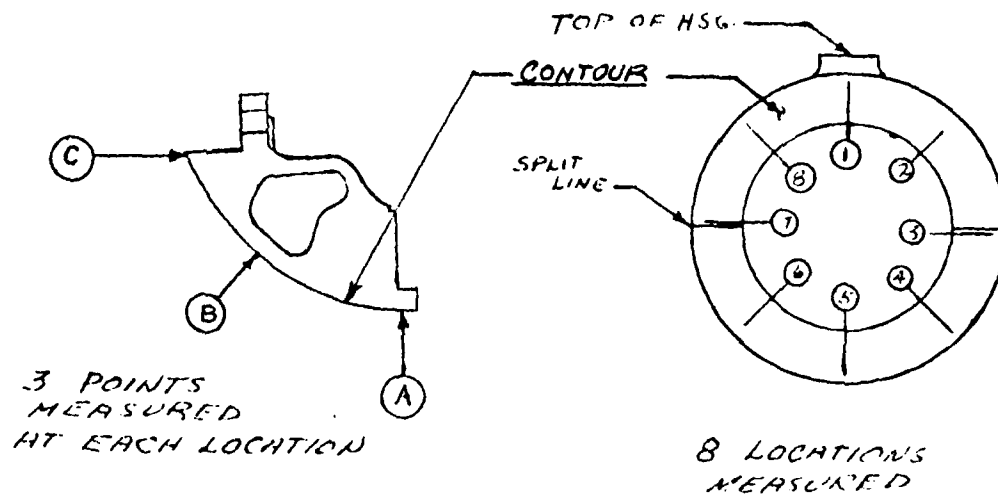
FORT RUCKER TEST ENGINE
CENTRIFUGAL COMPRESSOR HOUSING

b. See Figure 3 for dimensional data. It is interesting to note that the top half realized greater erosion damage than did the bottom half of the housing. The extreme erosion damage on this housing further attests to the severity of the Ft. Rucker test. This test housing (S/N XR9192) shall be used as a basis for comparison in future tests of this nature.

The below listed data concerns the measurement of the centrifugal compressor housing contour for erosion damage. Dimensions listed show extent of erosion below drawing minimum.

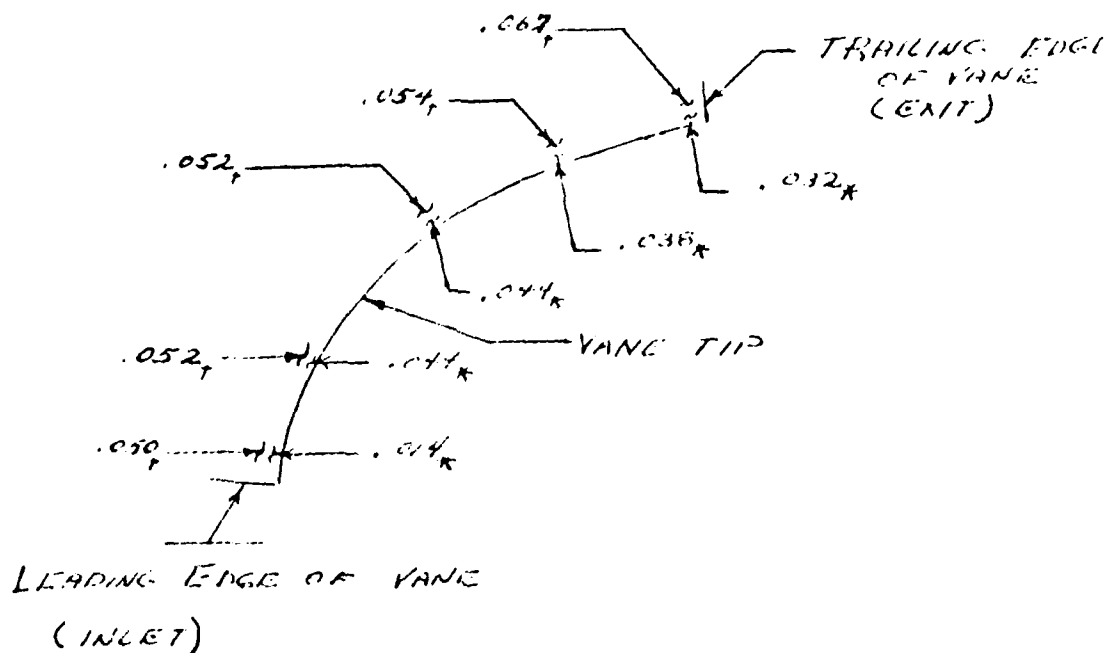
Figure 5

The below listed data concerns the vane thickness measurement as an inspection for erosion damage. One typical vane was measured five locations equally spaced along the blade length. Two measurements were taken at each location, 1/16 inch from vane tip and 3/8 inch from blade tip respectively.

*Measurement taken 1/16 inch from vane tip
+Measurement taken 3/8 inch from vane tip
